The Big Creek Research & Extension Team Project: Progress Update

BCRET

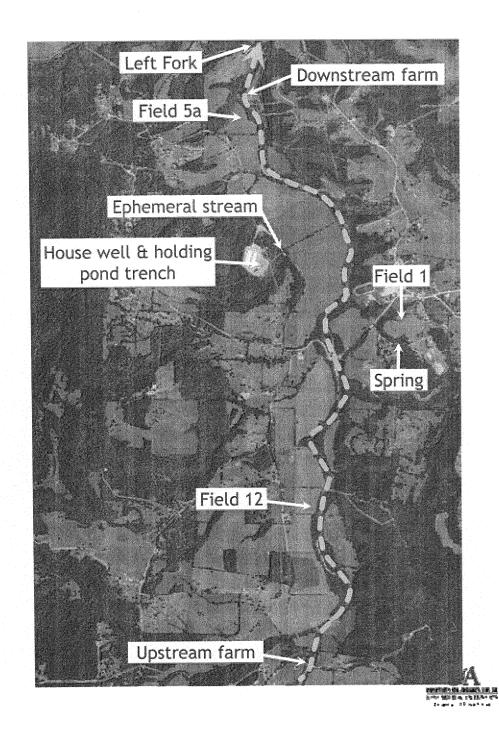
Current active water sample collection locations

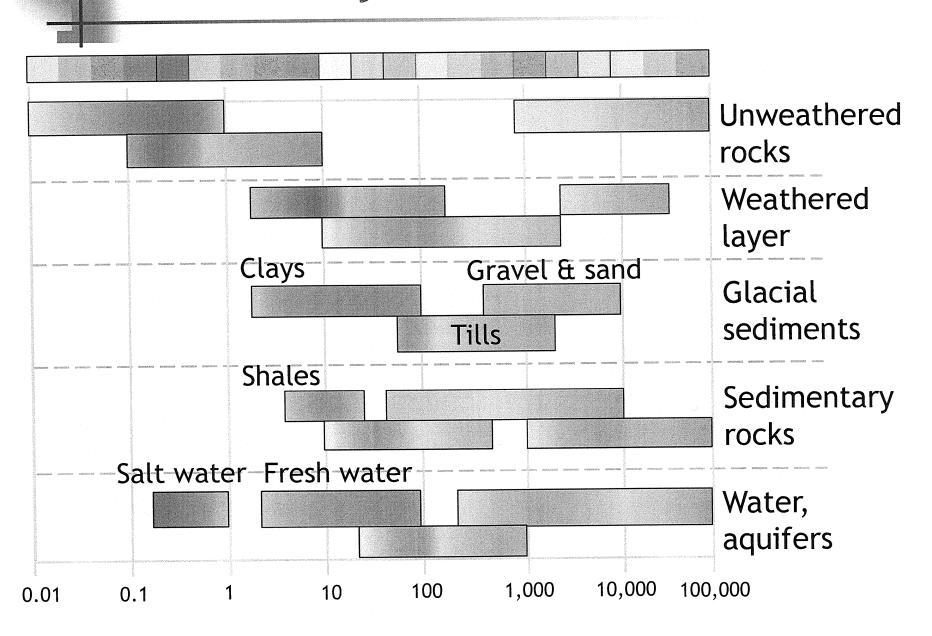
Resistivity of various materials

- A geophysical technique for imaging subsurface features from electrical resistivity measurements made at surface
- Graphical results are simply an image of contrasting resistivity of various materials with varying resistance/conductance in the subsurface
- Dry sand or clay has greater resistivity than wet sand/clay because pore water has a higher conductivity than that of solids & air

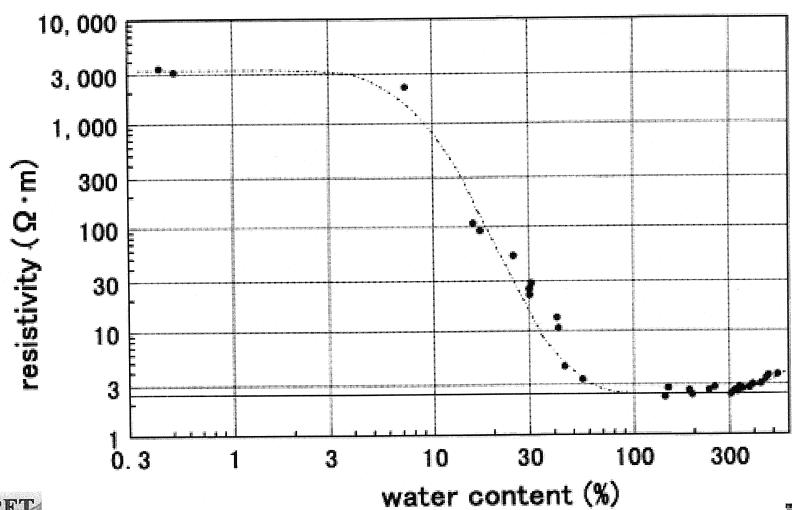
Affects of water content on

resistivity of Bentonite clay

- Trenches, house well, & ephemeral creek show no elevated levels of any tracer
 - Chloride is conservative tracer
 - EC, N, P, & E. coli show no consistent elevation
 - Resistivity of clays ranges from 12 to 25 Ohm-m, matches ERI values
 - Other national experts report that resistivity of manure plumes is much less than 1 Ohm-m

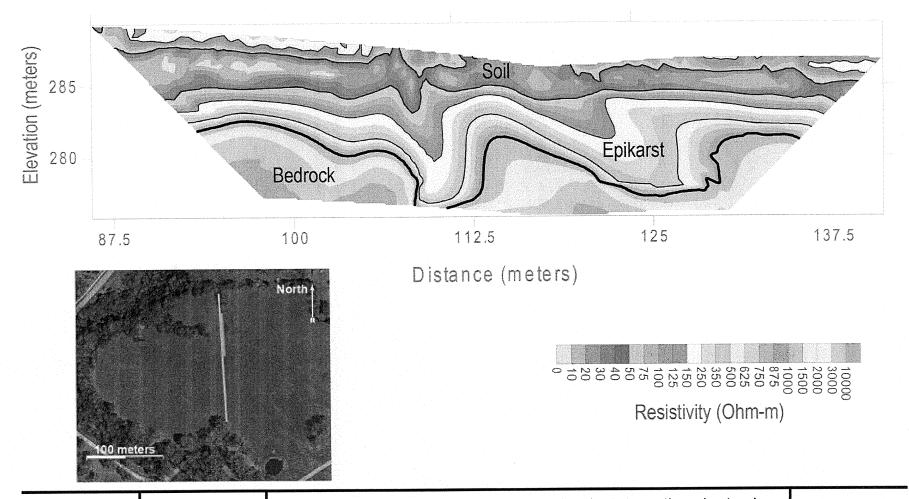
ERI for Field 1

South

North

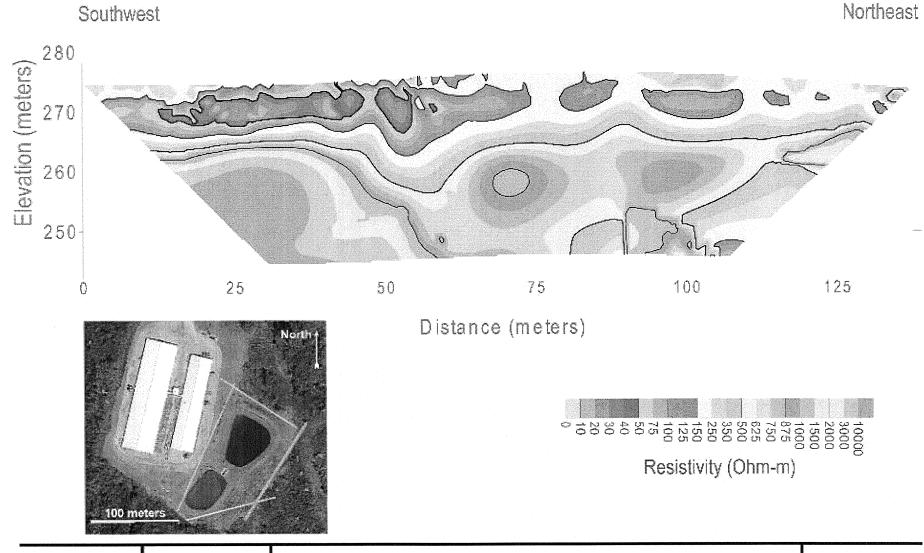
Figure A107

Holding **Ponds**

Transect MTJ107

This transect has a 2.5 meter spacing between the electrodes (1.25 meter resolution).

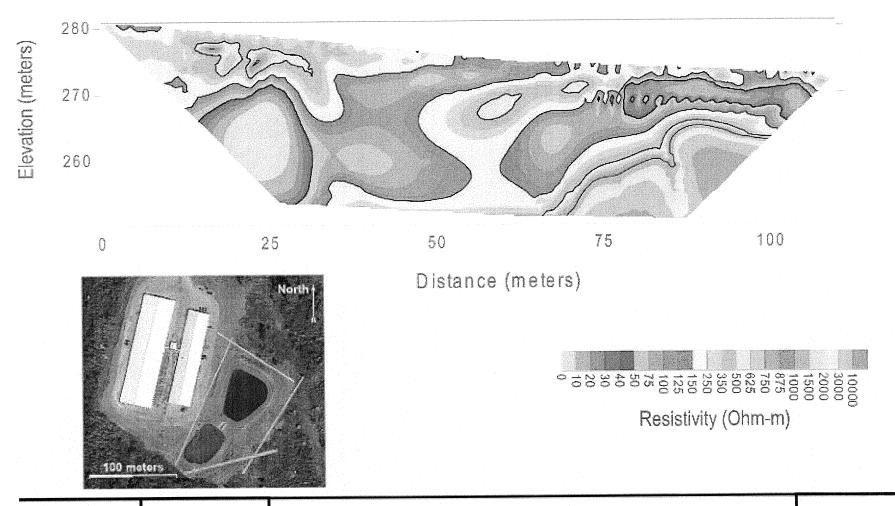
Figure A109

Holding Ponds

Transect MTJ109

This transect has a 2.0 meter spacing between the electrodes (1.0 meter resolution).

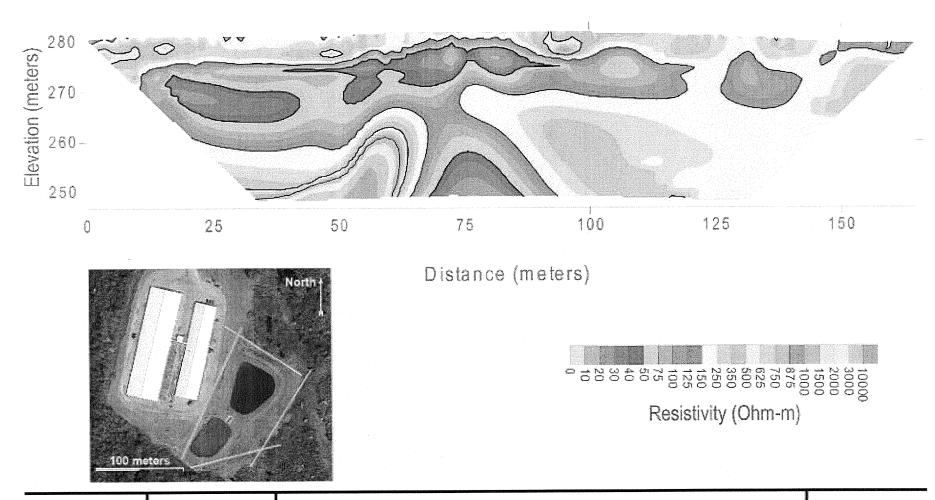
Figure A108

Holding Ponds

Transect MTJ108 This transect has a 3.0 meter spacing between the electrodes (1.5 meter resolution).

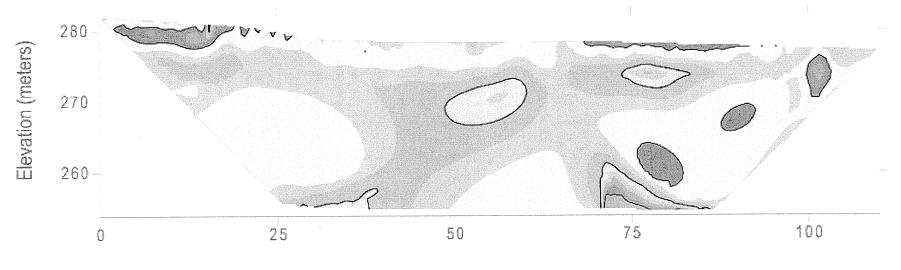
Figure A110

Distance (meters)

Holding Ponds

Transect MTJ110 This transect has a 2.0 meter spacing between the electrodes (1.0 meter resolution).

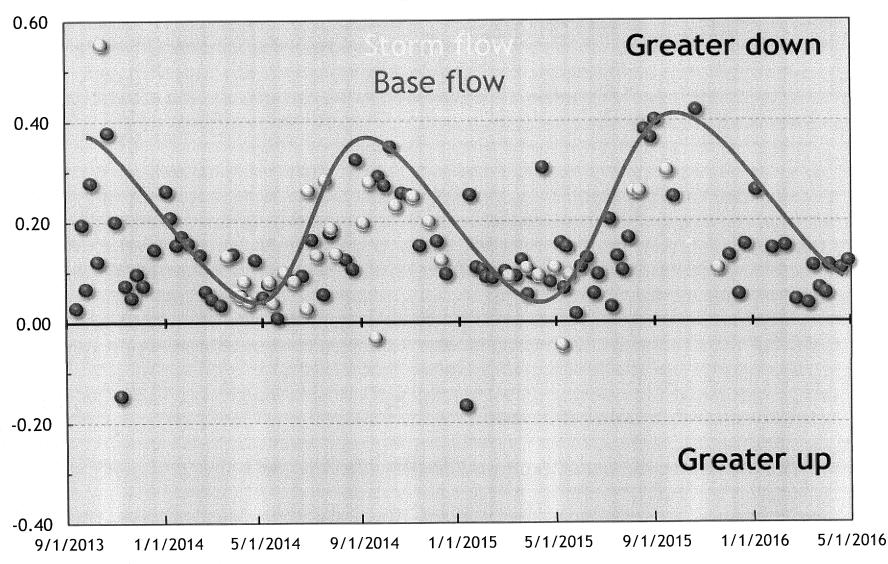
Nitrate-N (mg/L) difference between down & upstream sites

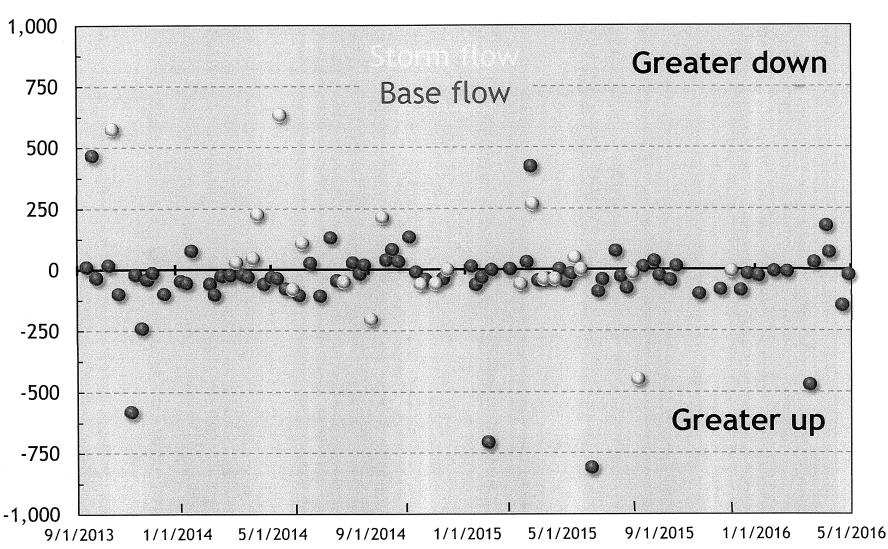
E. coli (MPN/100 mL) difference between down & upstream sites

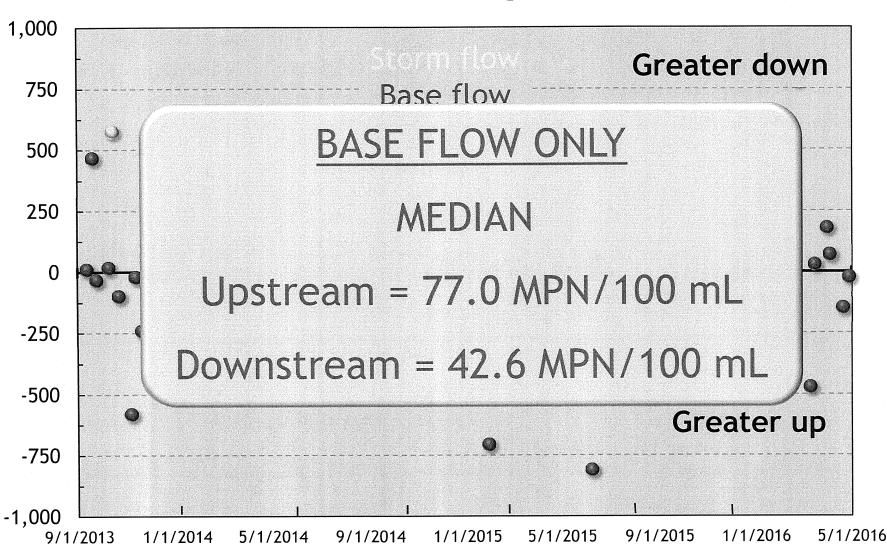
E. coli (MPN/100 mL) difference between down & upstream sites

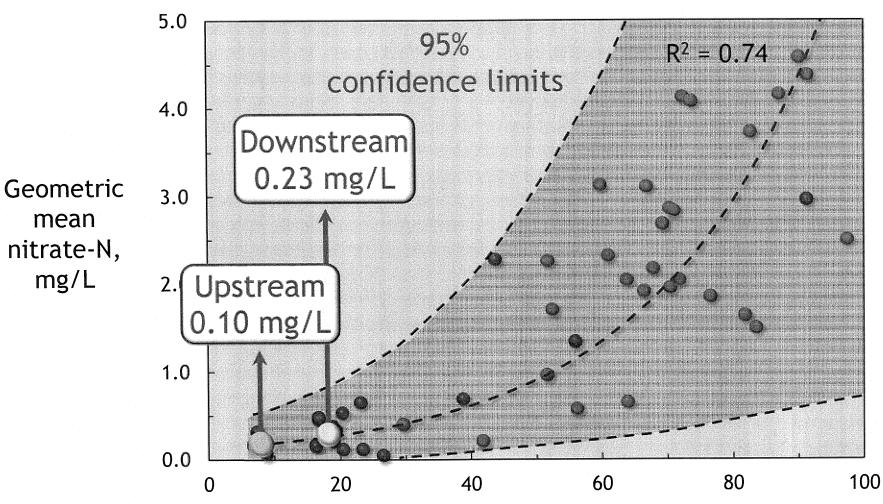
Beaver Reservoir Watershed Illinois River Watershed

Watershed land area as pasture & urban, %
