**IN THE CIRCUIT COURT OF GARLAND COUNTY, ARKANSAS
CIVIL DIVISION**

COMPLAINT

6. On or about October 12, 2023, Plaintiff purchased a home located at 16 Pego Circle, Hot Springs Village, Arkansas 71909, for \$202,575.65. This property will be referred to as the "Home" throughout this Complaint. [See Exhibit One - Contract for Purchase of Home and Exhibit Two - Settlement Statement].

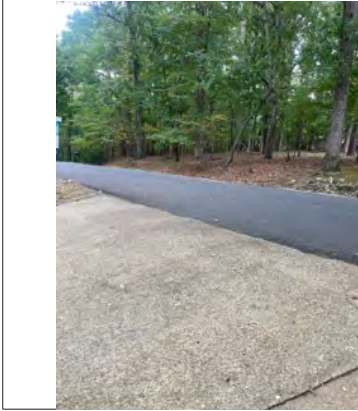
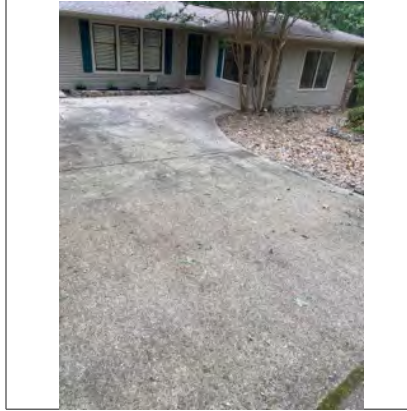
Condition Satisfactory Typical cracks

Comments As Concrete cures, over time, it is typical for the concrete to crack in driveways and patios as they are exposed to a wider range of temperature and weather. Recommend that the homeowner uses a good quality cement sealant to prolong the life of concrete when needed.

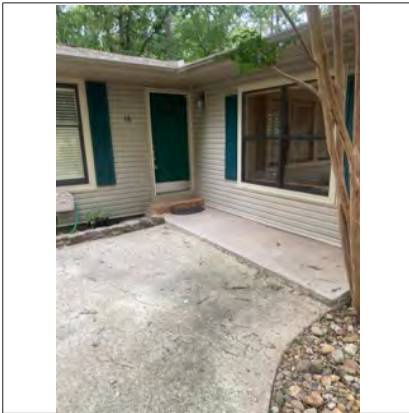
Porch

Condition Satisfactory Typical cracks

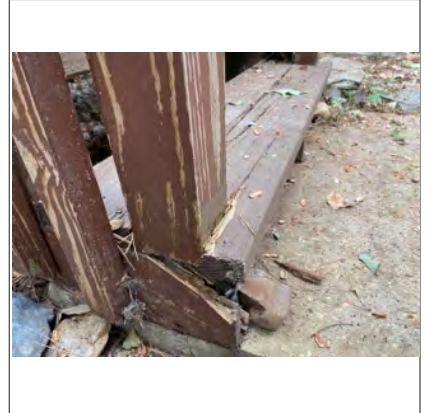
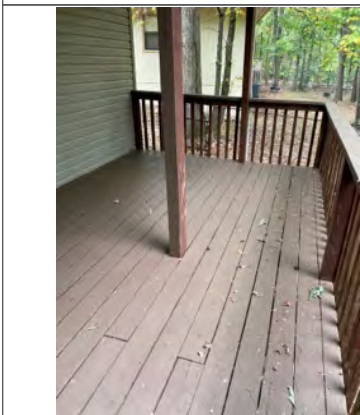
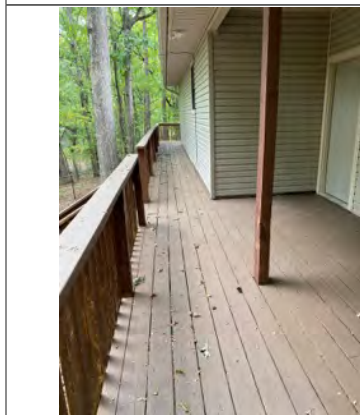
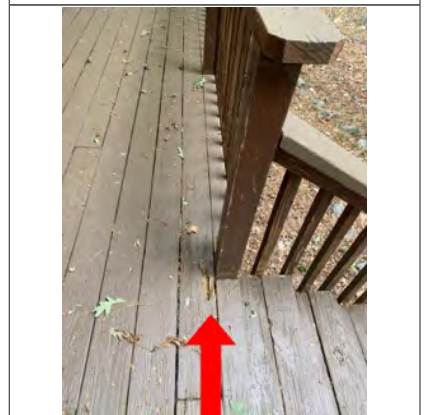
The left side of the steps has some wood deterioration but is stable. One board has some noticeable deterioration. Recommend repair

Wood deterioration

Recommend repair

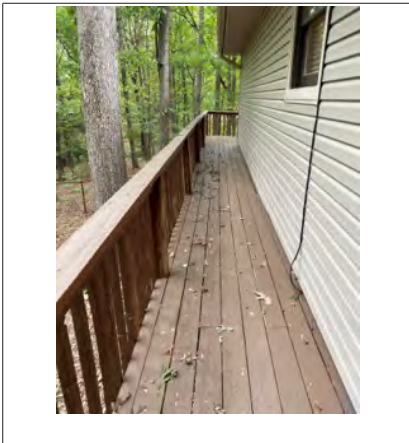
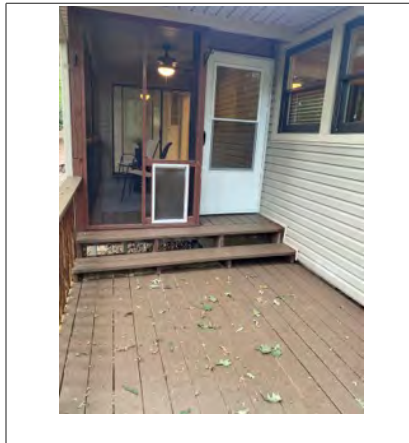
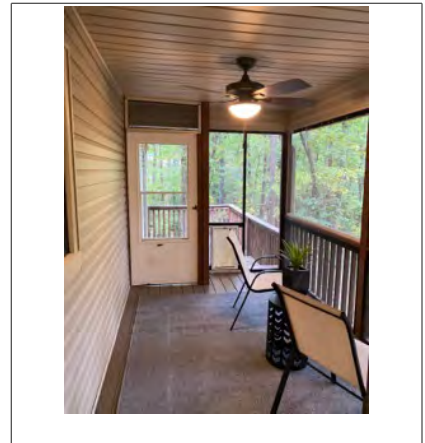
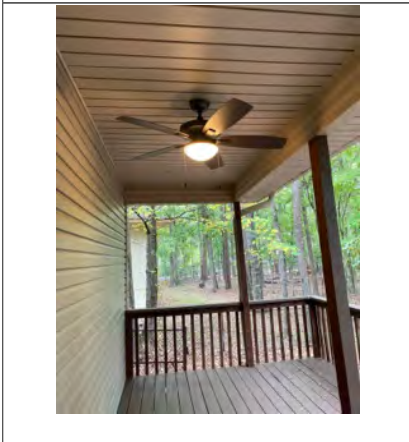
Wood deterioration

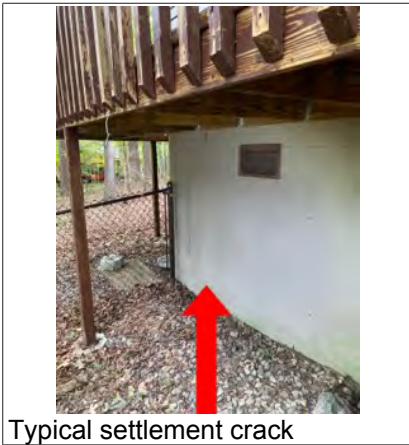
Typical settlement crack

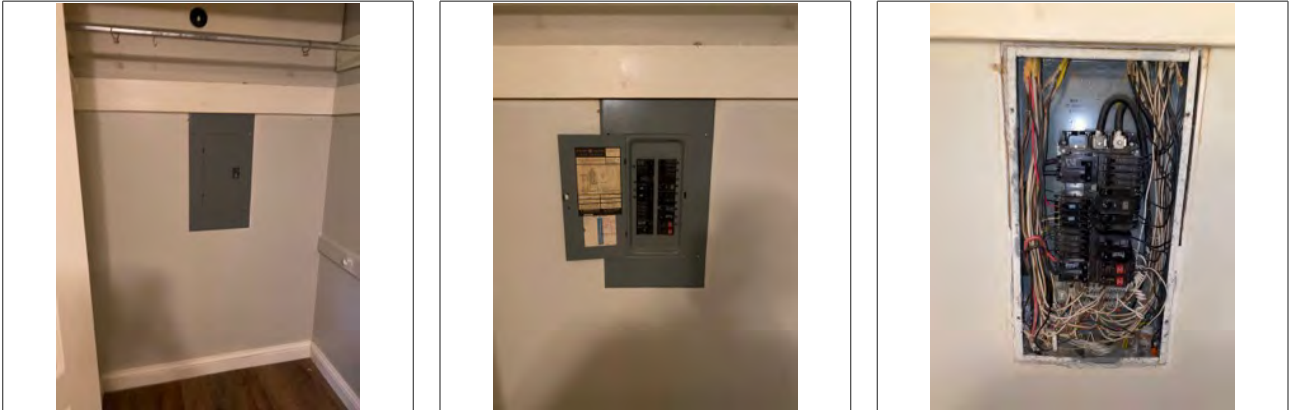
Comments Panel size appeared to be compatible to service size.
 Main disconnect was located outside at the meter.
 No signs of overheating were evident at the time of the inspection.
 Outlets were randomly tested and had correct polarity, unless otherwise noted within this report.

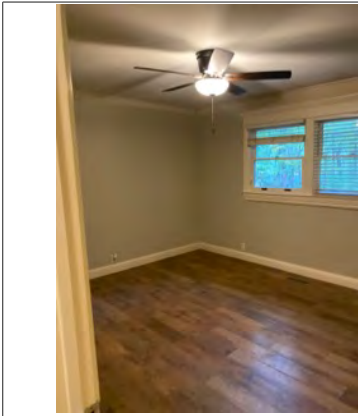
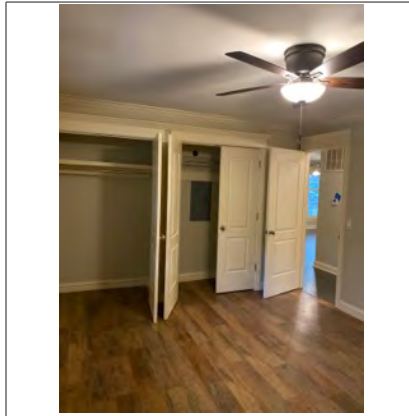
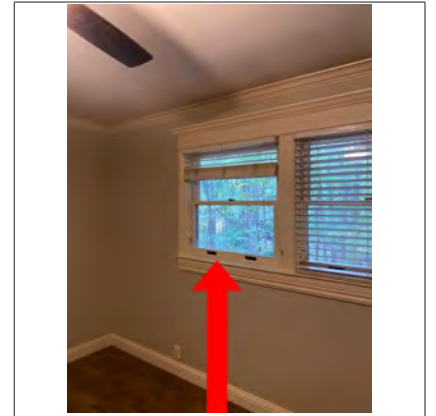
Bedroom
The back right North East bedroom window was painted shut and would not open. Recommend repair

The back right North East bedroom window was painted shut and would not open. Recommend repair

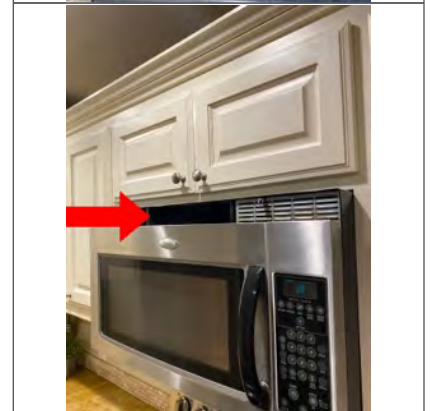
Light not operational recommend replacing bulb and further evaluation

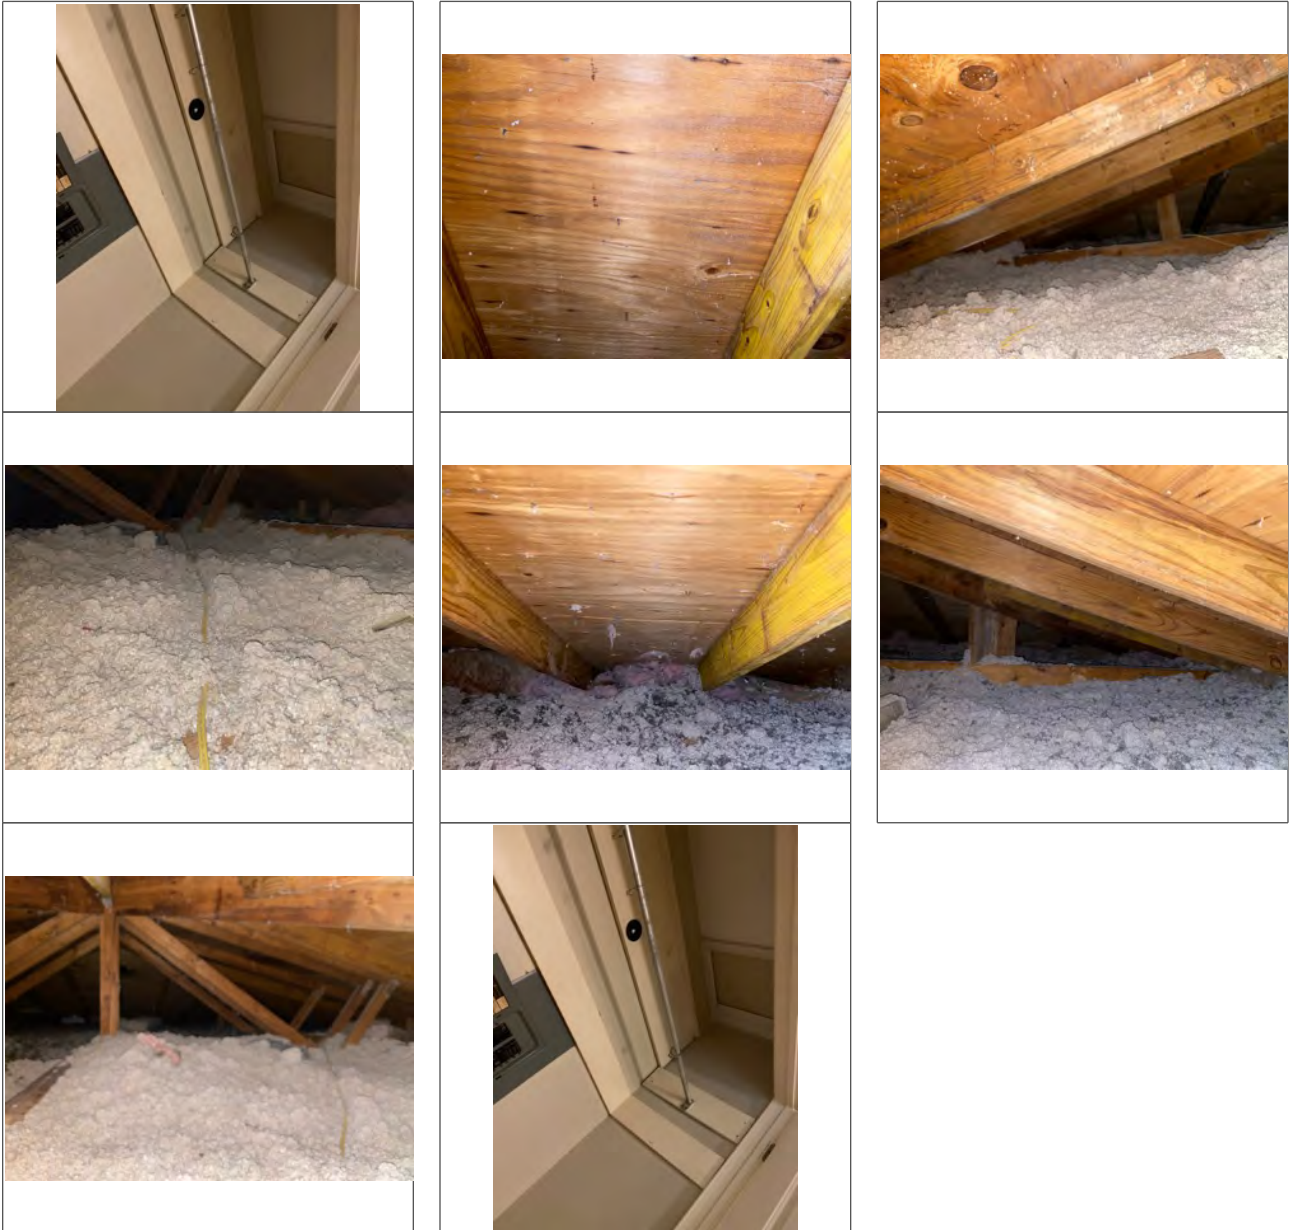
Comments Trusses showed no major defects or damage at the time of inspection.
Roof sheathing, examined from the attic, showed no major defects or moisture damage.
Insulation was sufficient for homes in this area.
Insulation was typical for this house design.

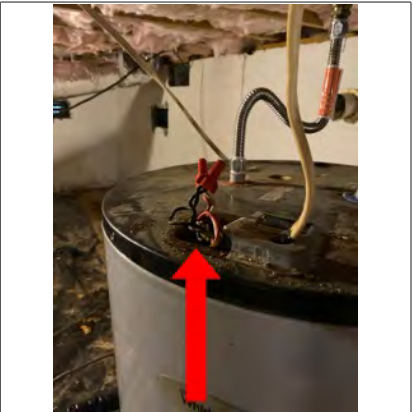
The connection point has exposed electrical wires. Recommend adding service cover. This is not a huge deal because it's in the crawlspace however recommend repair as desired

Exposed electrical wiring

The connection point has exposed electrical wires. Recommend adding service cover. This is not a huge deal because it's in the crawlspace however recommend repair as desired

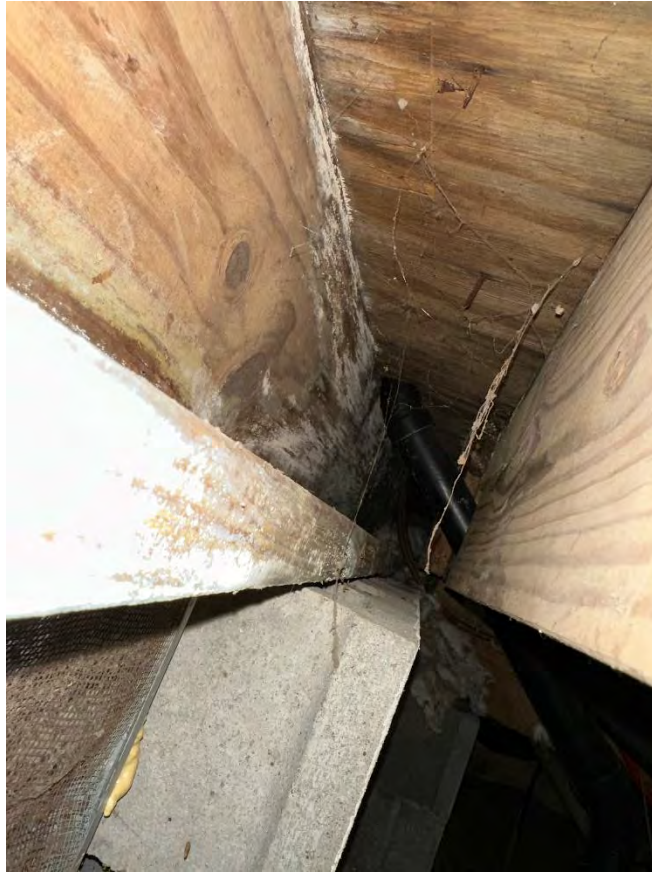
Photo 8. View of crawlspace substructure near kitchen drainage pipe illustrating visible mold growth and moisture staining

13. At Plaintiff's request, a mold inspection was conducted by Atoka Inc. on November 20, 2023. The inspection revealed extensive mold growth in the kitchen and crawl space, which was contributing to the Home's unpleasant odor and health concerns. The report recommended immediate remediation. [See Exhibit Six - Atoka Mold Report].

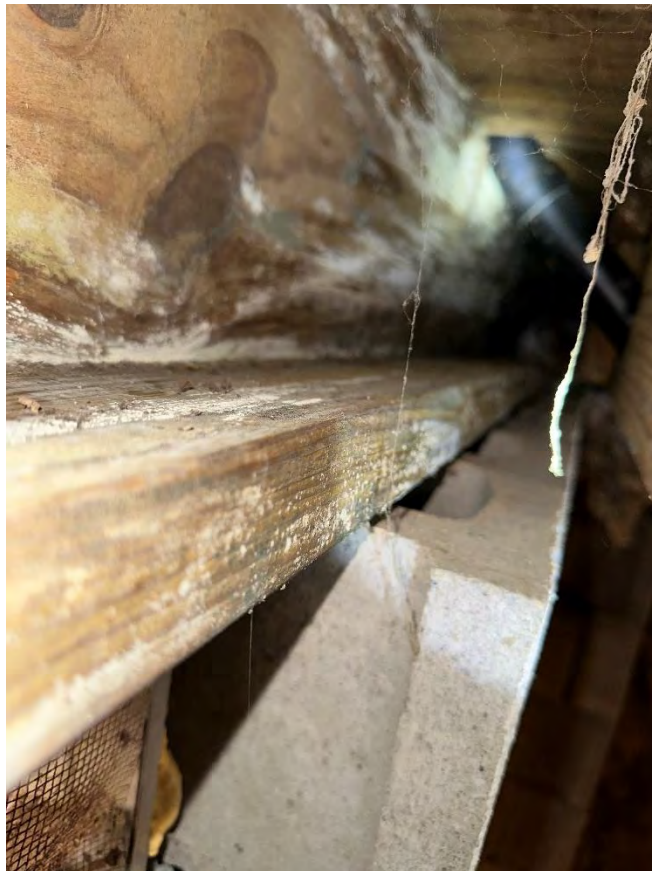
Photo 9. View 2 of crawlspace substructure near kitchen drainage pipe illustrating visible mold growth and moisture staining

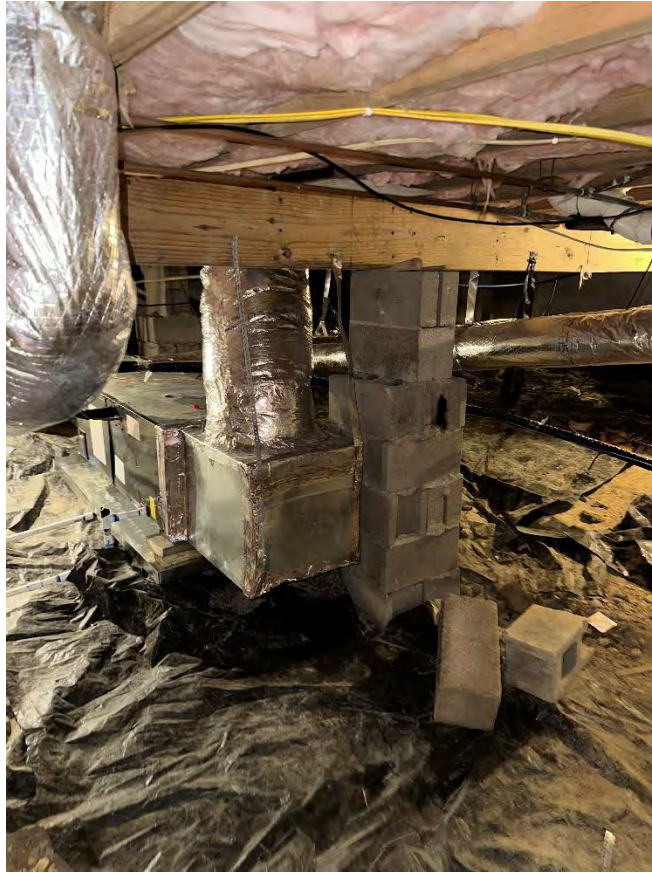
Photo 10. HVAC system and view of current crawlspace vapor barrier
